A Progress Report on the Service Life of Reflectorized Guide Signs Installed on the Roseville Freeway, Highway 40

December 1959

State of California
Department of Public Works
Division of Highways
Materials and Research Department

Progress Report

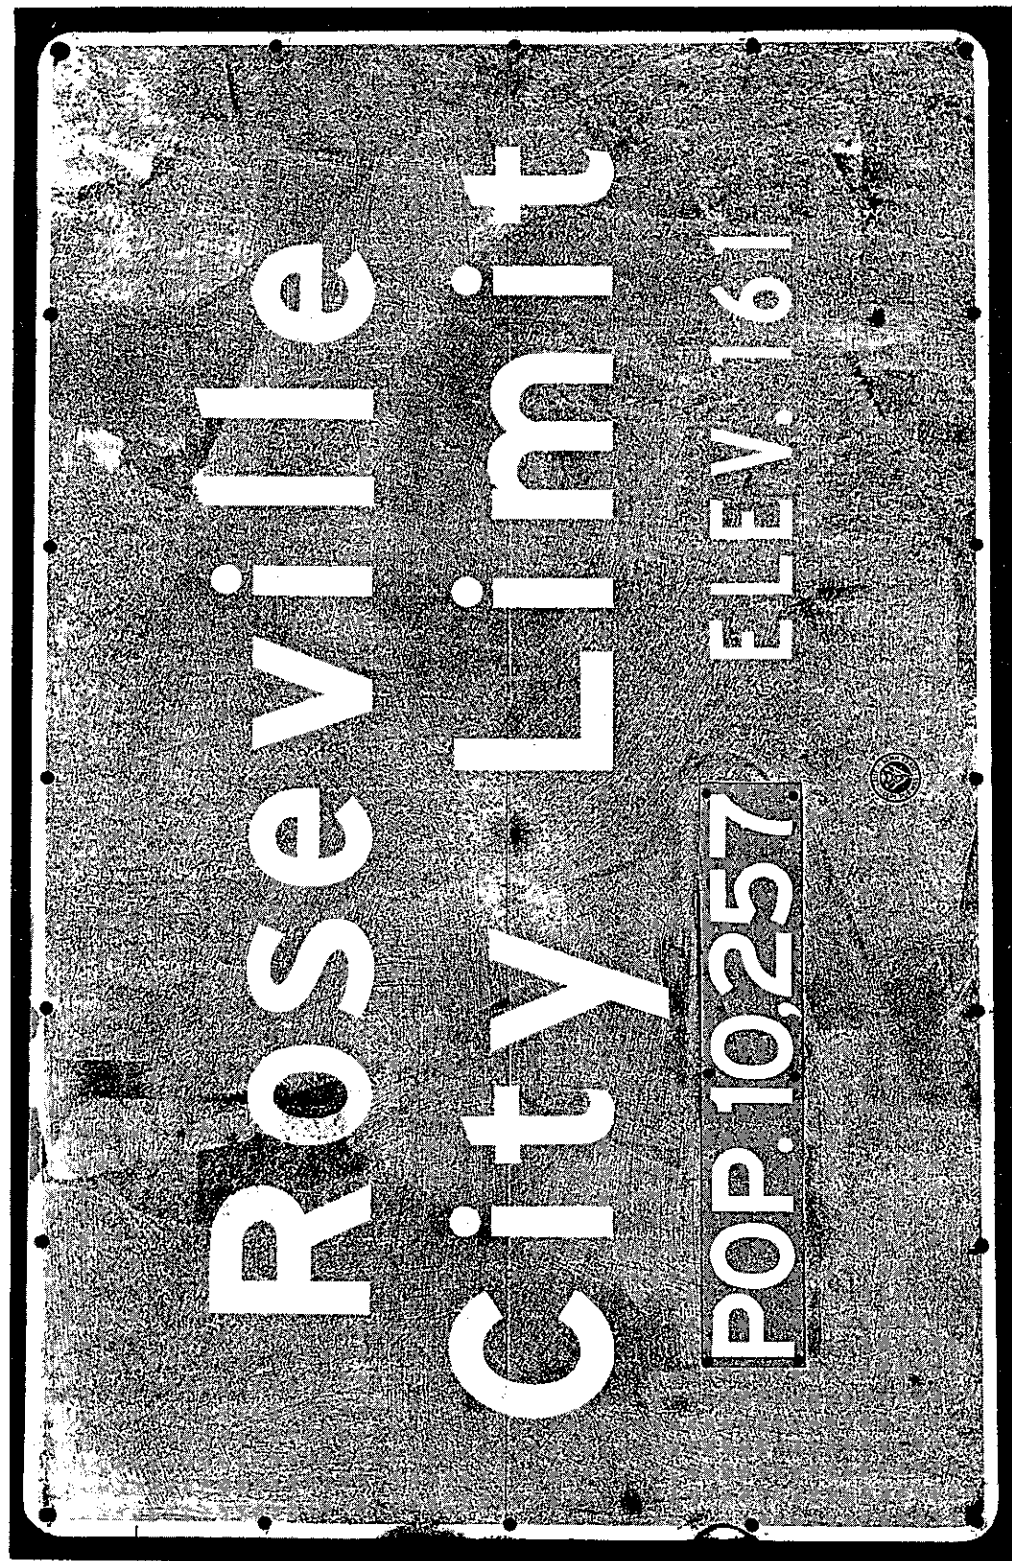
Nighttime appearance of South facing sign showing surface condition and loss of reflectance after approximately three years of service.

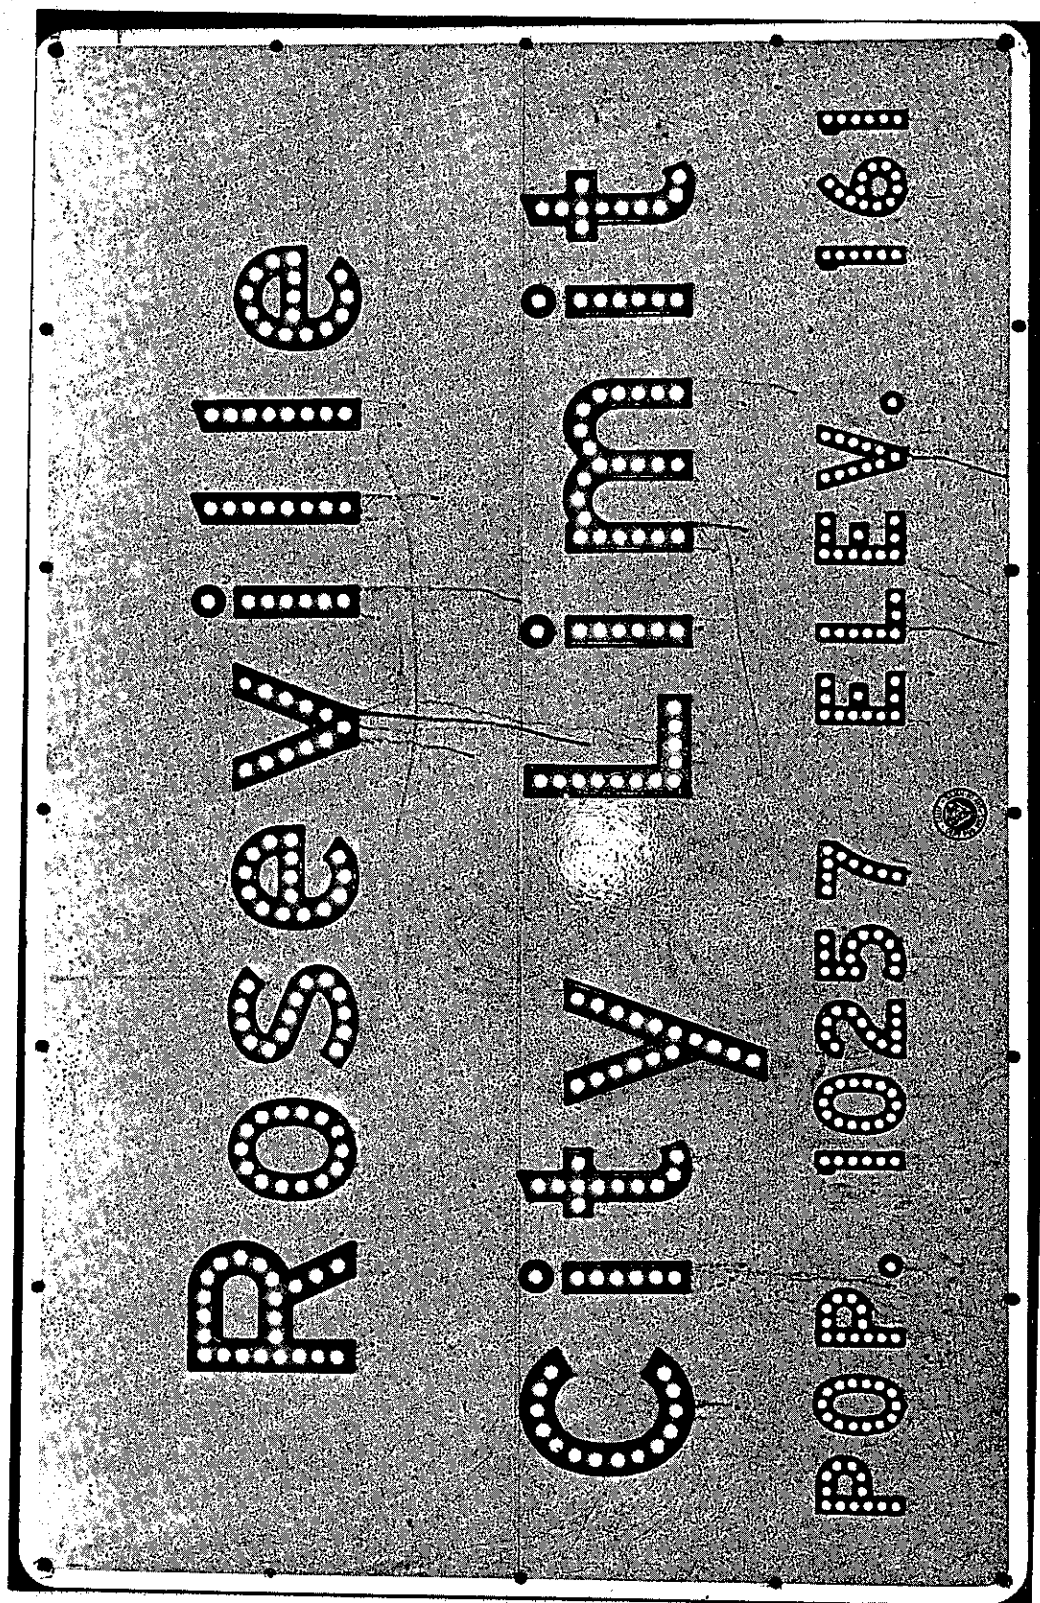
Nighttime appearance of North facing sign showing the good condition of the Scotchlite after approximately three years service. The runs occurred when applying the second seal coat.

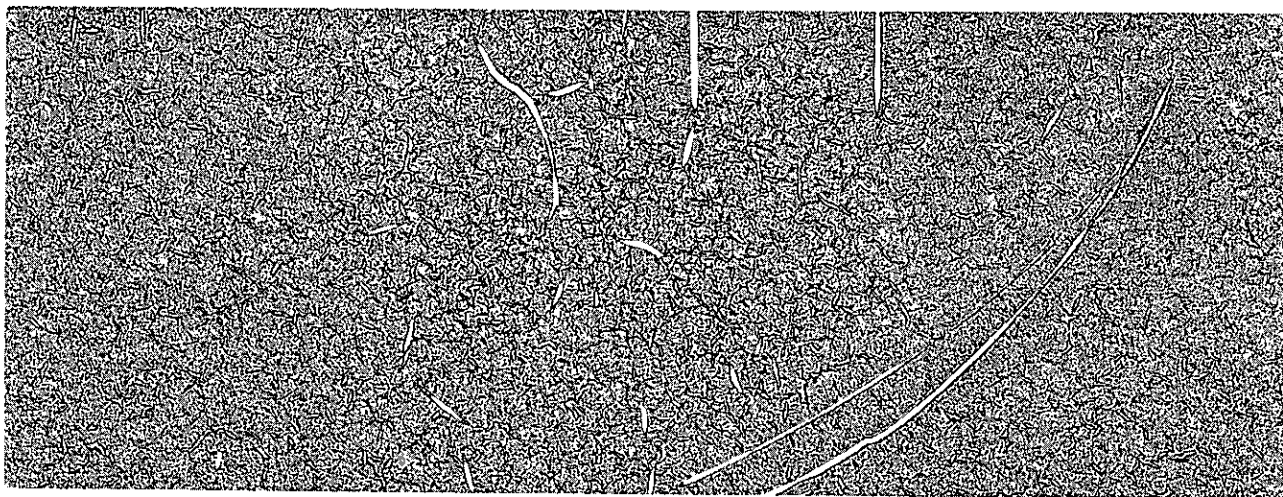
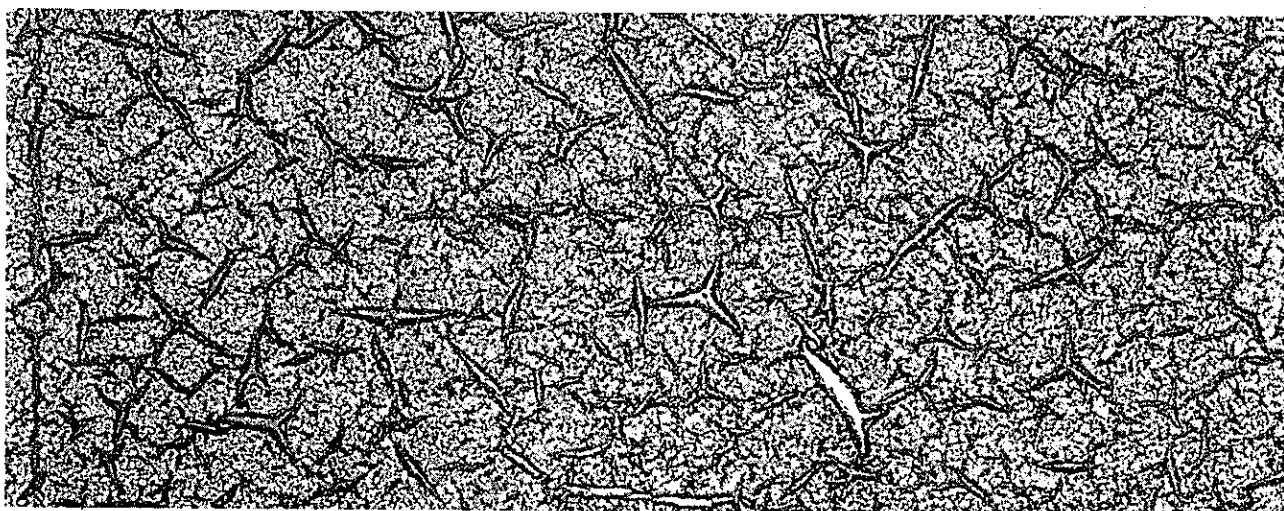
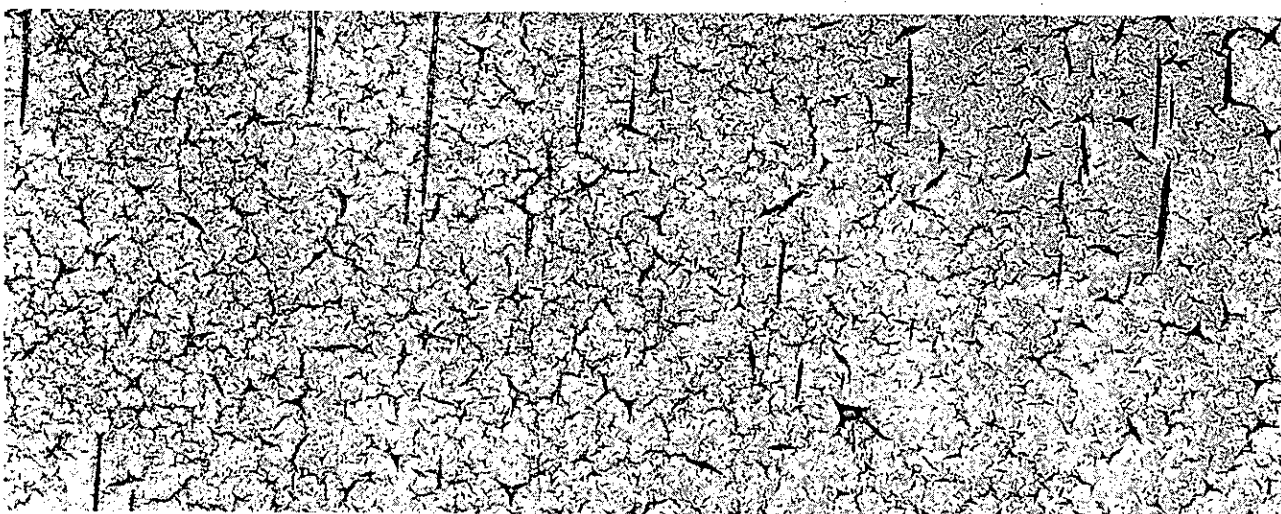
Exhibits 5 and 6 show the severe checking and surface condition on the test panels after 4 1/2 years of south exposure.

Flat-top Scotchlite - 4 1/2 years South exposure on
Sacramento Test Rack. Top to bottom: Red, Yellow, Silver

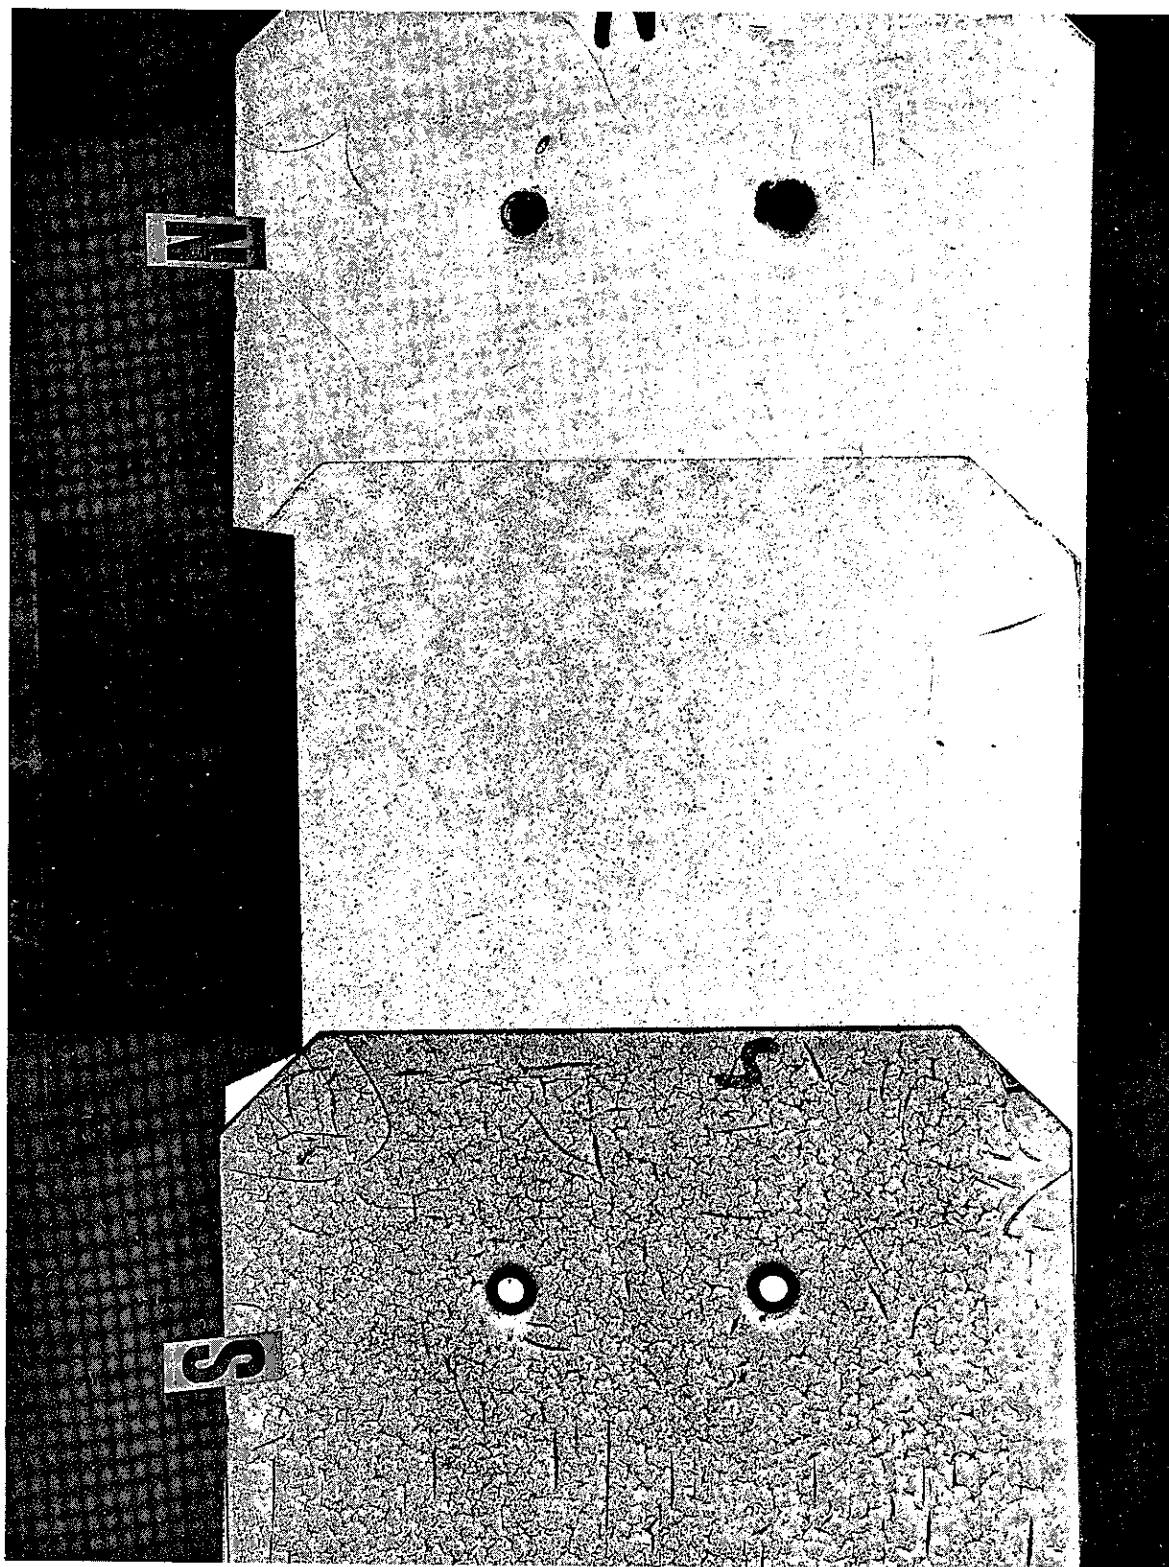
Silver Flat-top Scotchlite: Nighttime appearance after 4 1/2 years exposure on Sacramento Test Rack. Top to bottom: North exposed, unexposed control panel, south exposed.

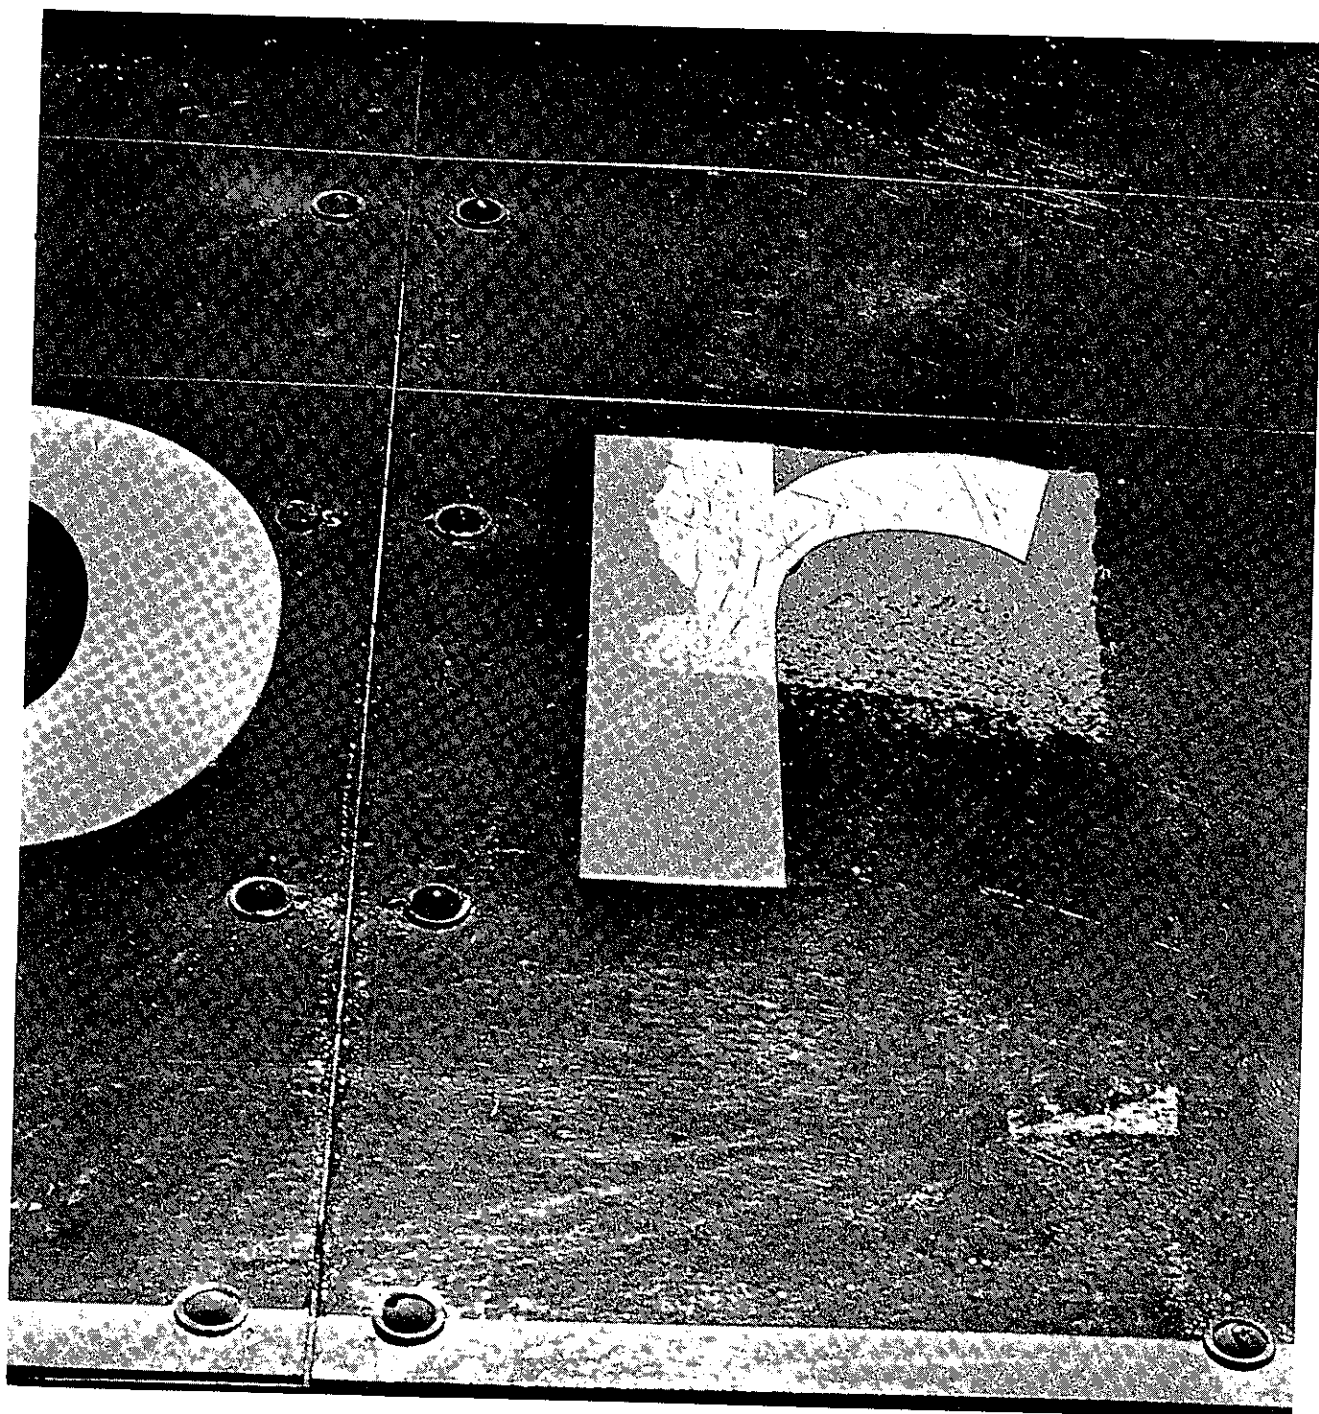
The overhead signs are still in good condition. The background appears darker than new green Scotchlite, but this may be the result of differences in production runs of Scotchlite. No deterioration is detectable on any of the signs facing north (south-bound lanes). The only checking noted on the south-facing signs has occurred in small areas which were missed when the last seal coat was applied (see Exhibit 7). Judging from the present condition of these signs, they may be expected to serve a minimum of 3 to 6 years more.

Overhead, South exposed sign showing weathering in area not protected by field applied clear-coat.

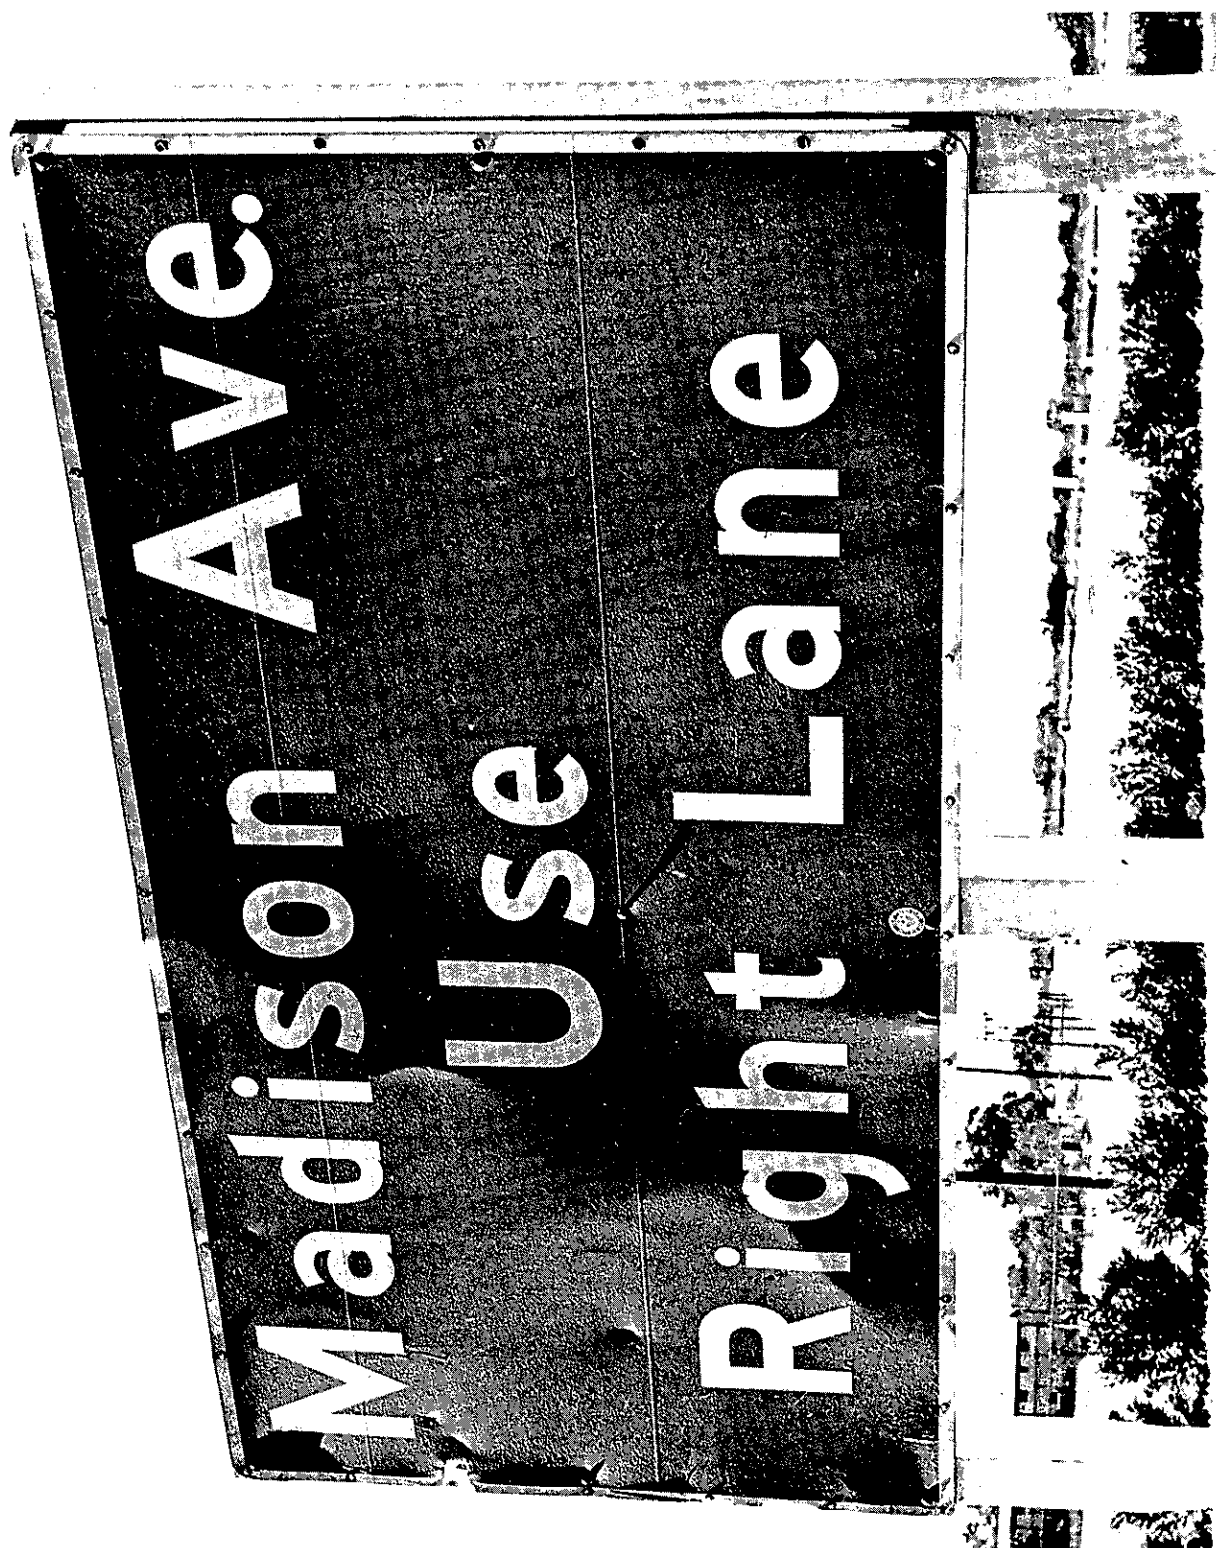
There is no noticeable weathering deterioration of any of these signs. Two signs were knocked down and bent by traffic, straightened, and returned to service (see Exhibit 8). Slight checking evident in the background and legend of these signs is a result of bending and straightening of the sign.

Severely damaged sign straightened by field crew and immediately returned to service. Damaged areas are not noticeable to passing motorists, day or night.

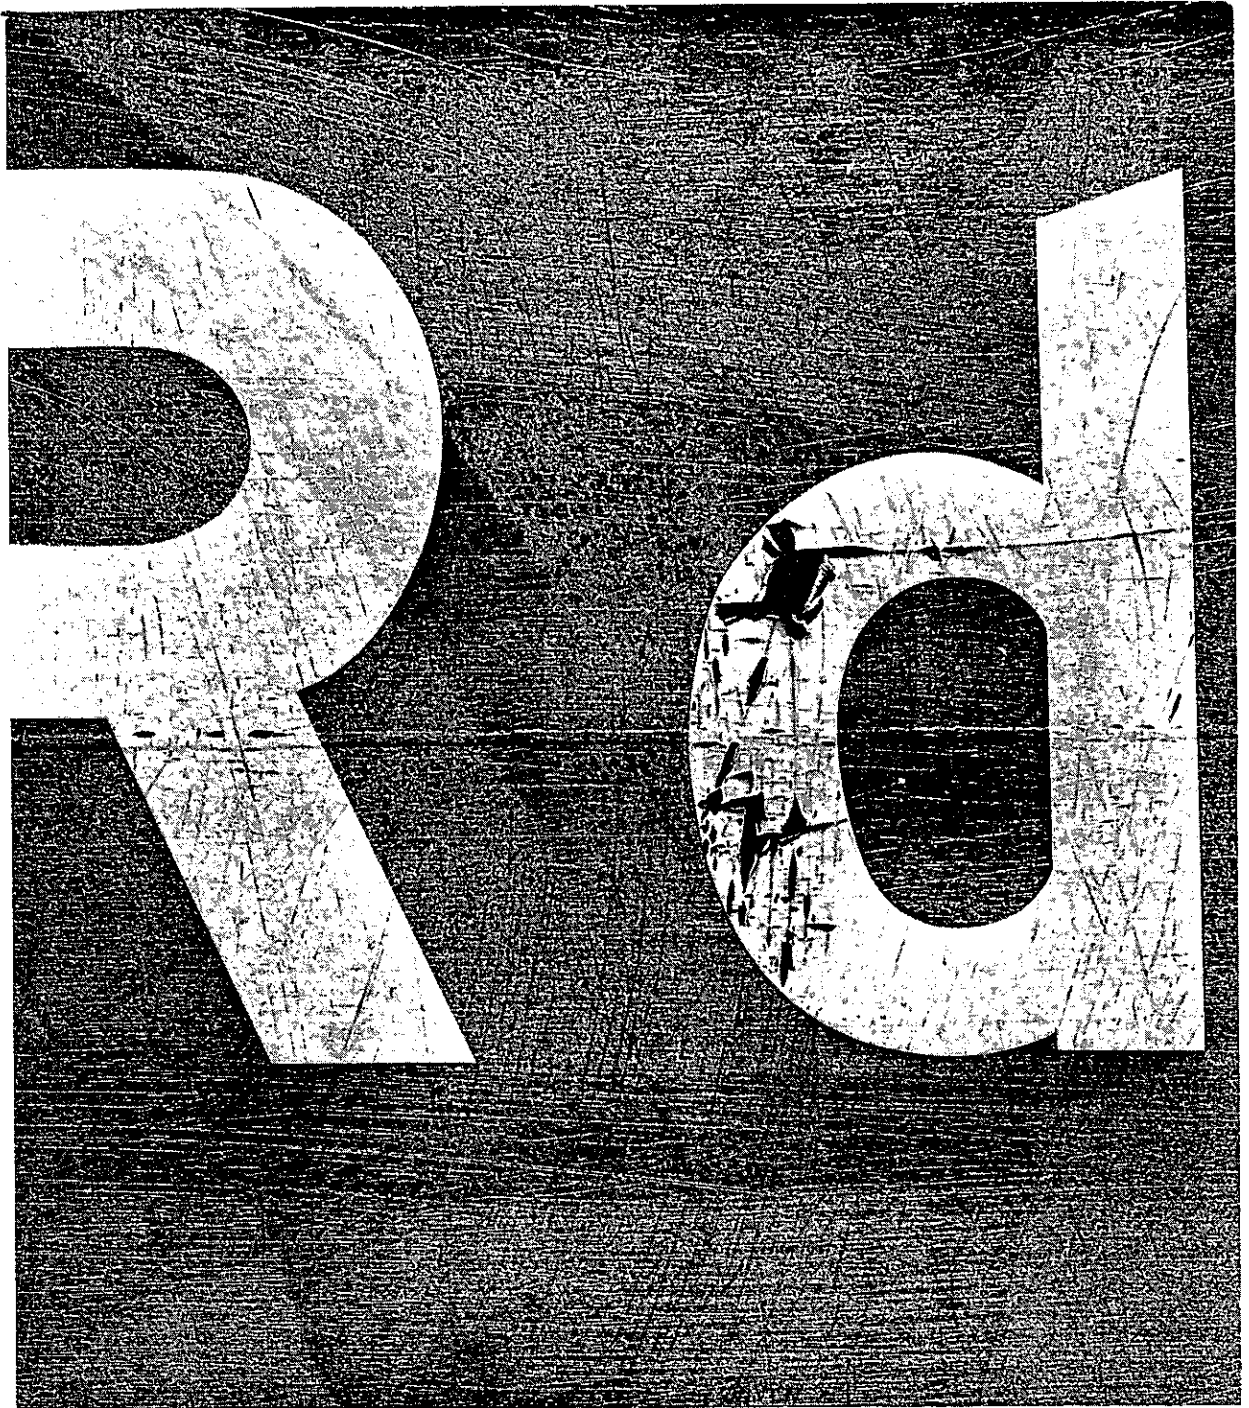
Cracking and checking has progressed on 9 of the 13 signs to the extent that the letters are starting to peel off, (see Exhibit 9). The background material has checked through to the base metal on several signs. The daytime appearance of these signs is poor, and the nighttime appearance is unacceptable. Under reflected light the message is difficult to read because the background and legend appear patchy and streaked. The background color varies from green to greenish-gray, and the legend color varies from silver to gray (see Exhibit 10).

South exposed Scotchlite, shoulder-mounted sign, showing peeling of the legend after 3 1/2 years service.

B. The following signs should be removed from the Roseville Freeway as early as is convenient for stripping and refurbishing with green Scotchlite background and A.G.A. legend. Four of these signs have A.G.A. legends which can be salvaged.

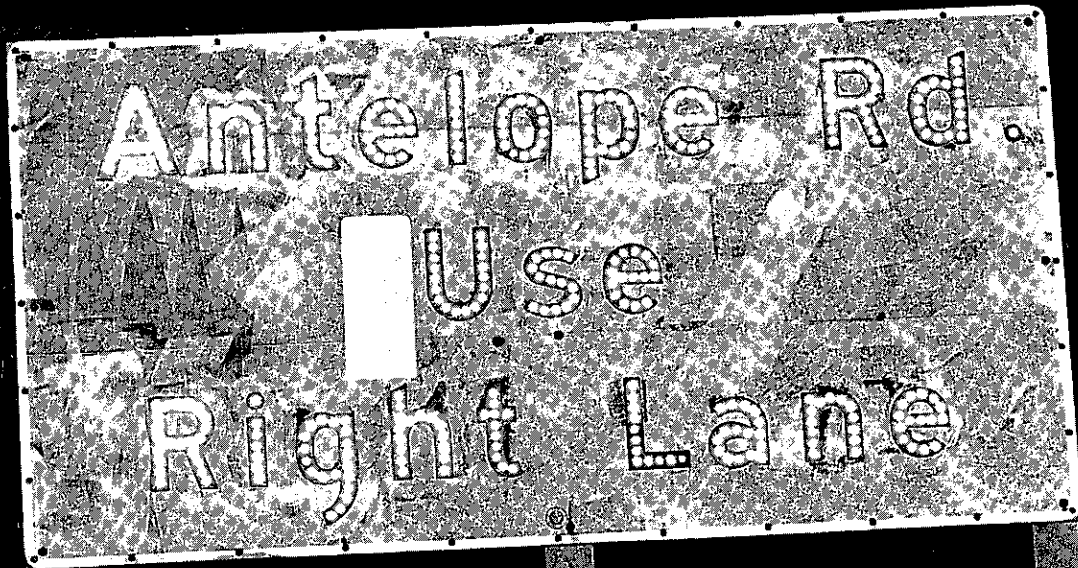
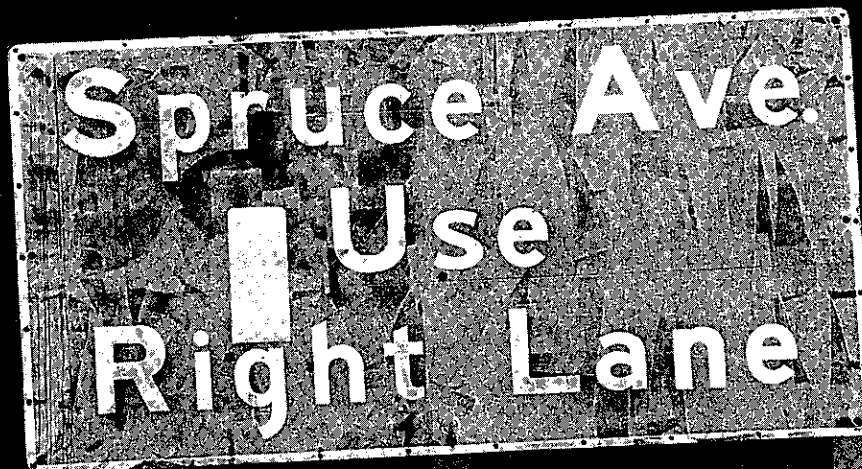
South exposed, shoulder-mounted signs showing patchy appearance under reflected light. The bright area on each sign is a green Scotchlite Laboratory control panel. The last two letters in "Lane" on bottom sign are Silver Scotchlite Laboratory control letters.

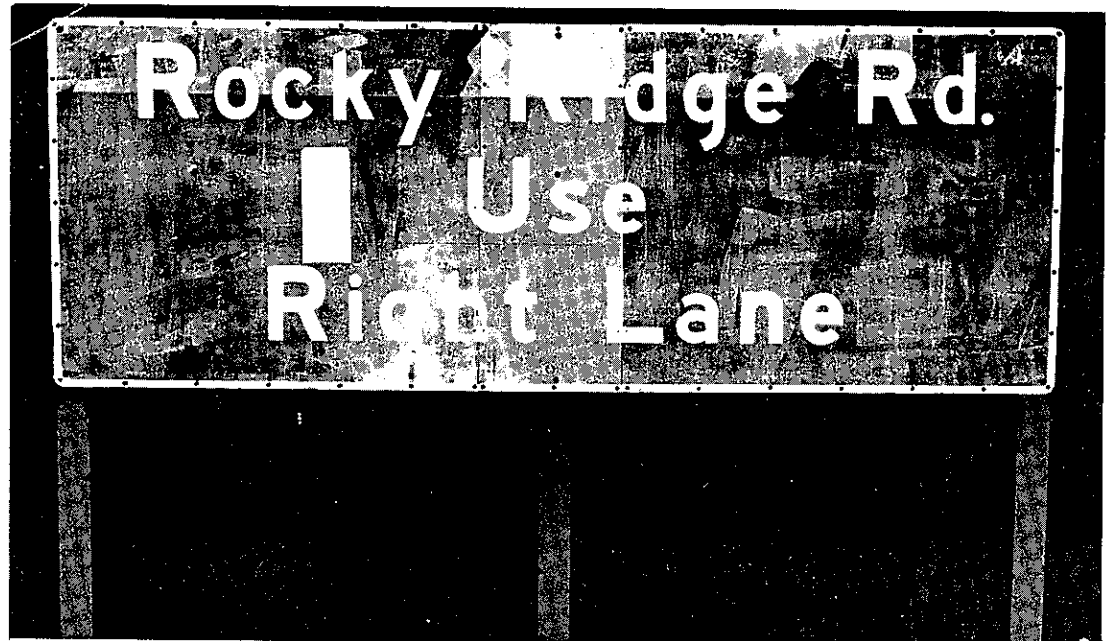
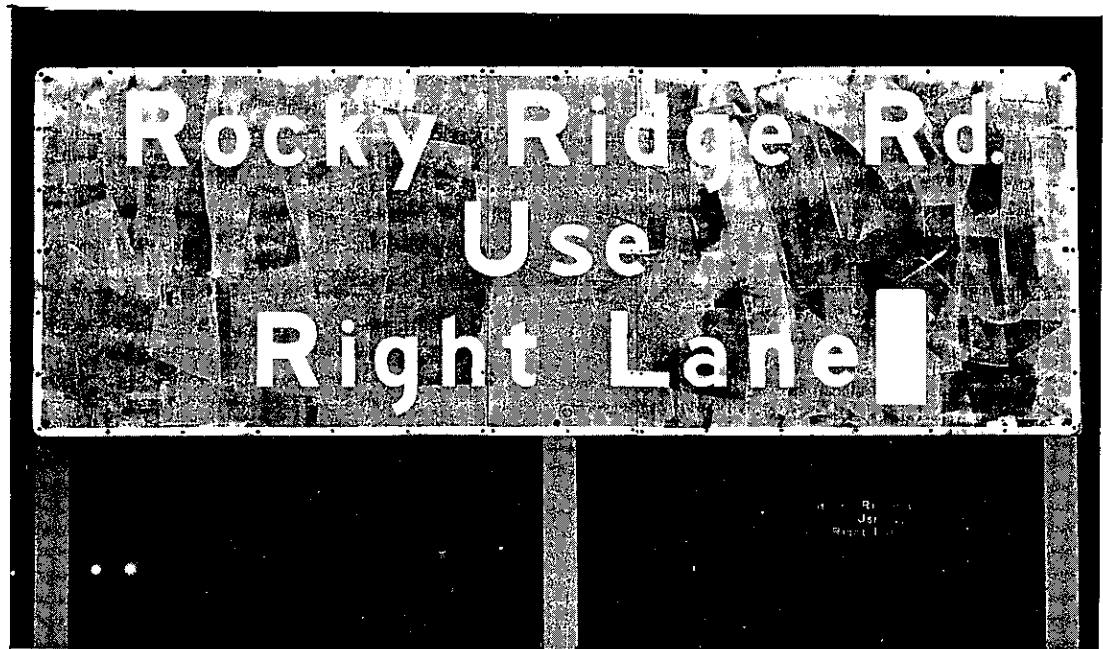
were less than 48 inches wide. Further evidence of the value of a heavy clear coat is found in connection with the center panels of two south-facing, shoulder-mounted Rocky Ridge Road signs. The original plans specified a total sign length that was 24" less than required to maintain standard spacing of the legend. The 144" panels were split at the center and a two foot center section was added. The center panels received a heavier roller-applied clear coat while the side panels were clear coated by spray applications. The background and letters on these narrow center panels are in much better condition than the larger side panels (see Exhibits 11 and 12).

All the sign panels showing early failures were clear coated by the spray method. There is no evidence of accelerated deterioration on any of the roller-coated panels. This difference apparently is not due to the method of application but is rather due to the fact that the roller method results in a thicker coating. The protection the heavy roller-applied coat provides is particularly evident on the Rocky Ridge Road signs, where the center panels are in considerably better condition than the larger side panels (see Exhibits 11 and 12).

Shoulder-mounted, South exposed Scotchlite signs, showing difference in nighttime appearance between center panels and outside panels. Note difference in weathering of the two productions of Scotchlite above and below top splice joint seam on top picture. The "n" and "e" in "Lane" of both pictures are laboratory control letters.

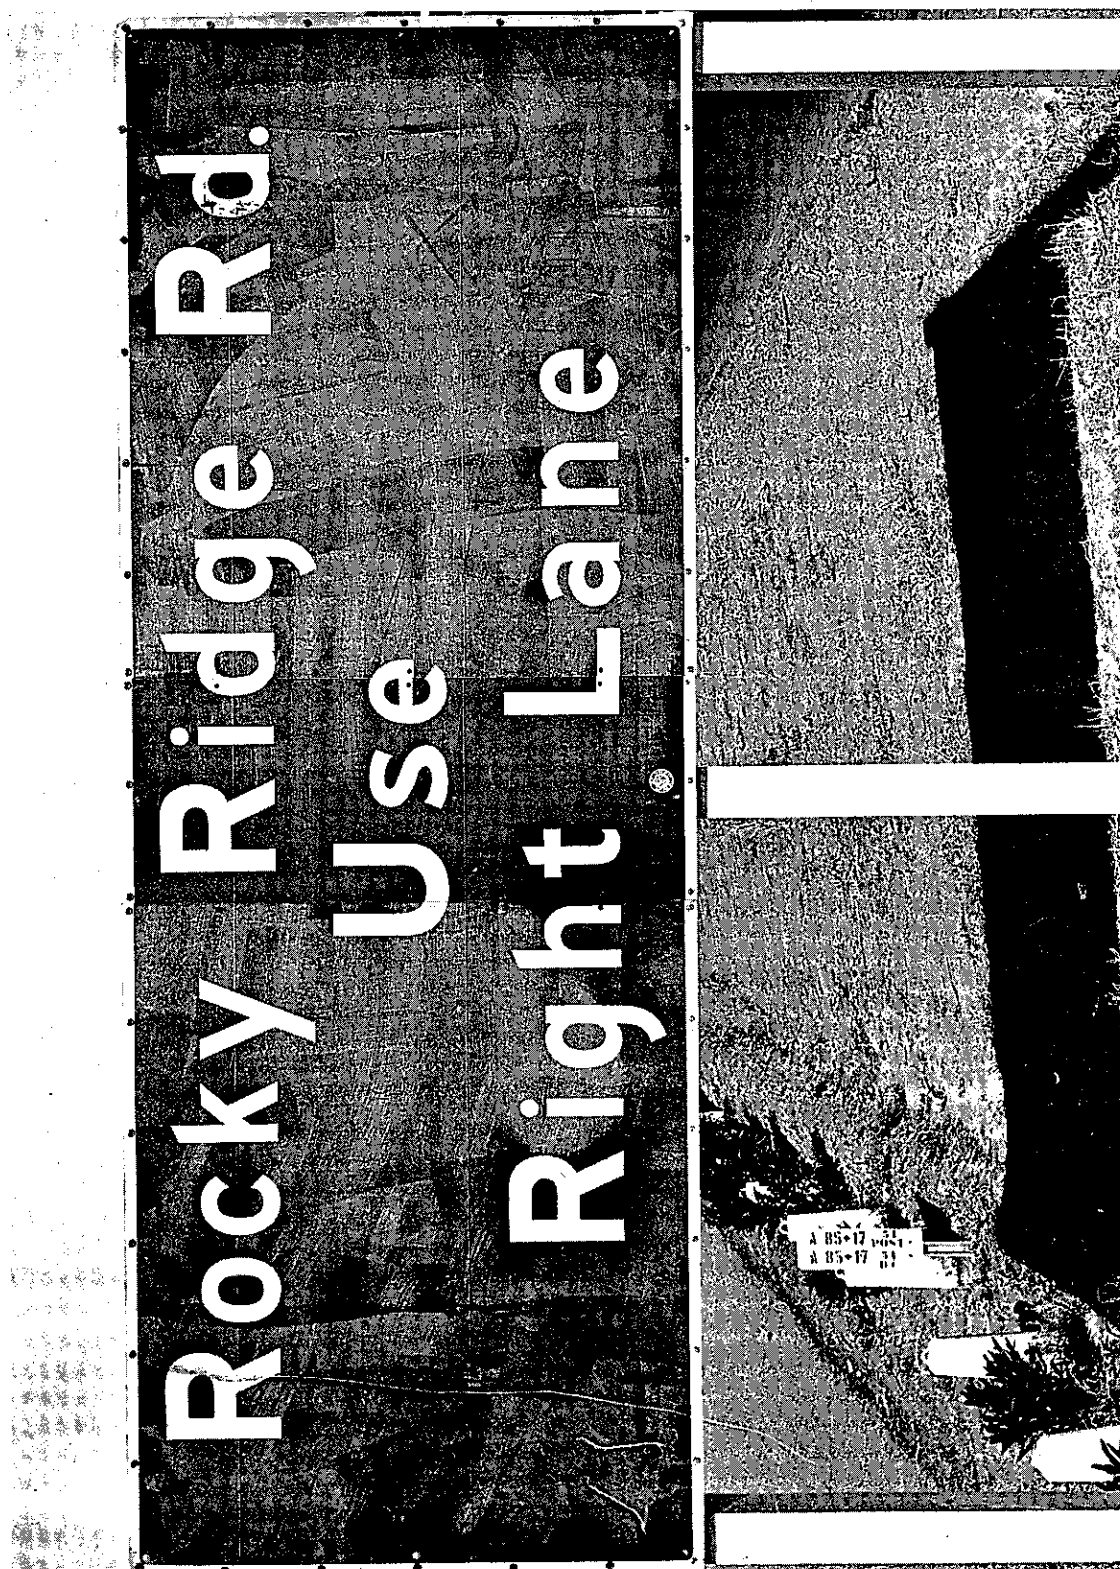
Shoulder-mounted, South exposed Scotchlite sign. Daytime appearance of sign in Exhibit 11, bottom. Note difference in weathering of outside panels and of center panel.

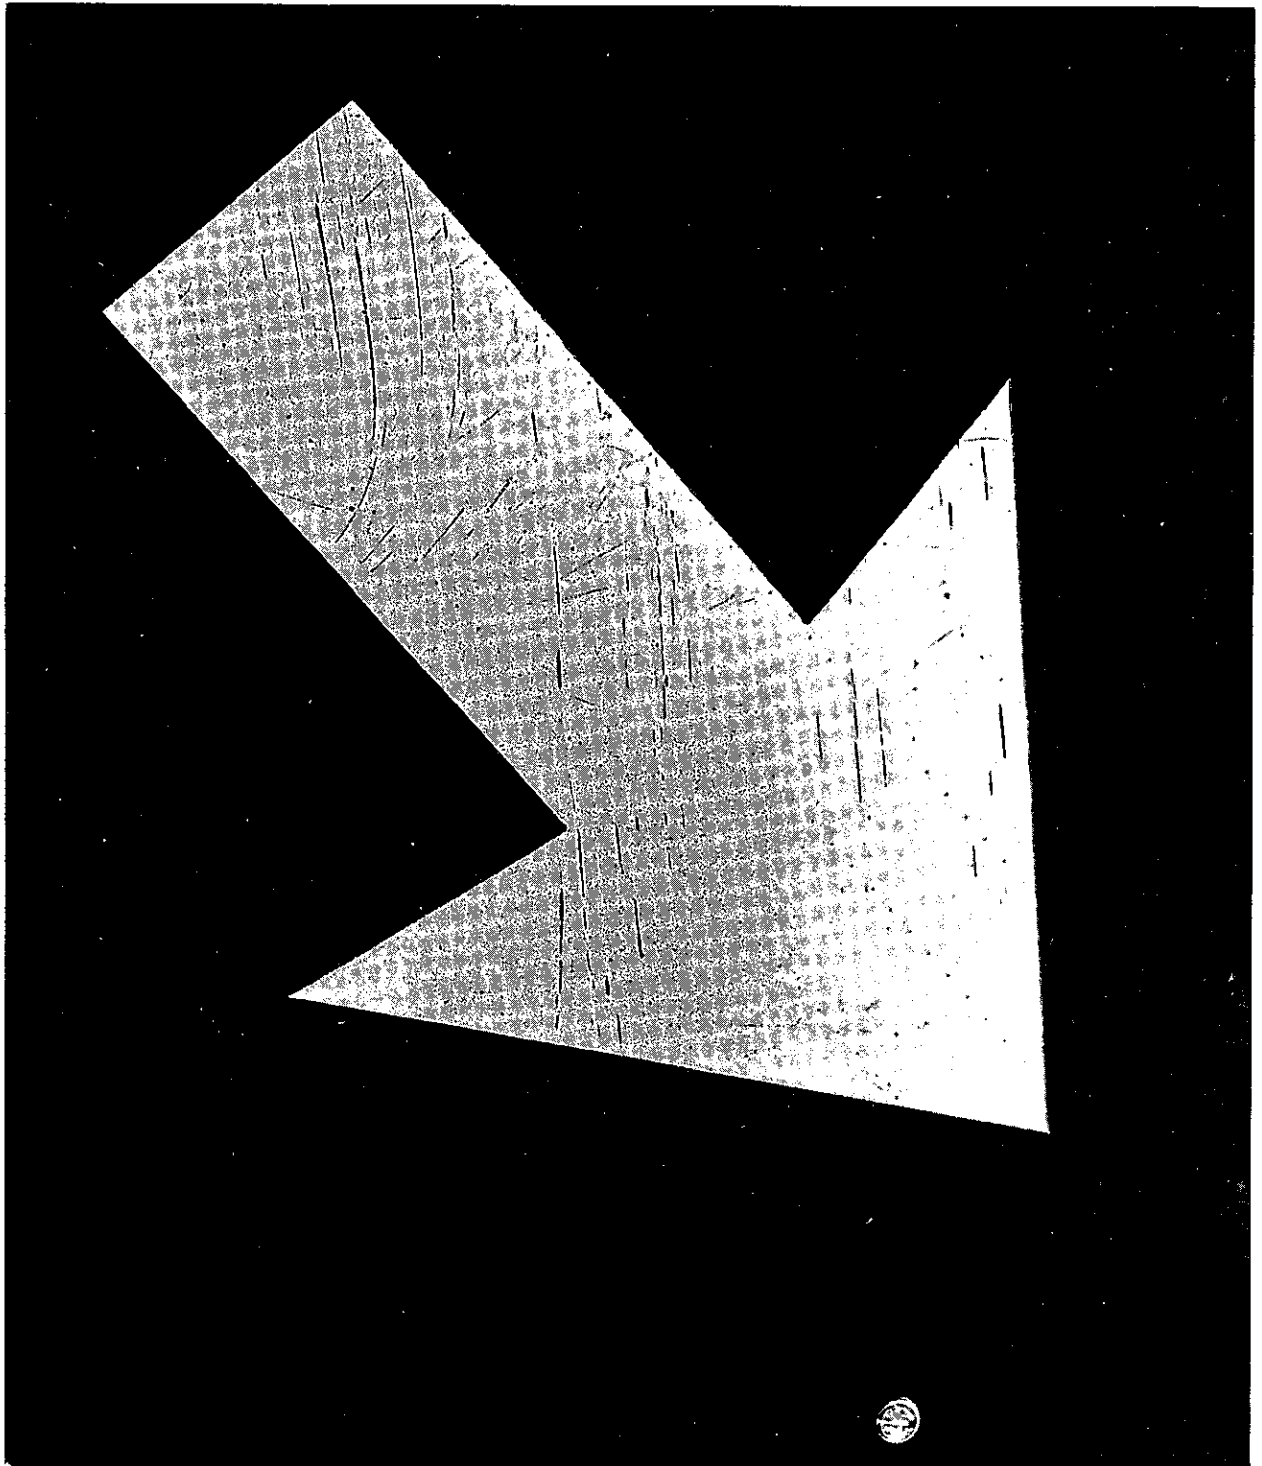
The checking of these letters is evident on signs facing south and west as shown in Exhibit 13. No checking was evident on any of the north facing signs (see Exhibit 14).

Similarly, the Scotchlite letters on black porcelain signs facing north are still in good condition, while those exposed to afternoon sunlight are checking and cracking (see Exhibits 13 and 14).

Shoulder-mounted, South facing Silver Scotchlite
legend on black porcelain enamel. Deterioration
after 3 1/2 years service.

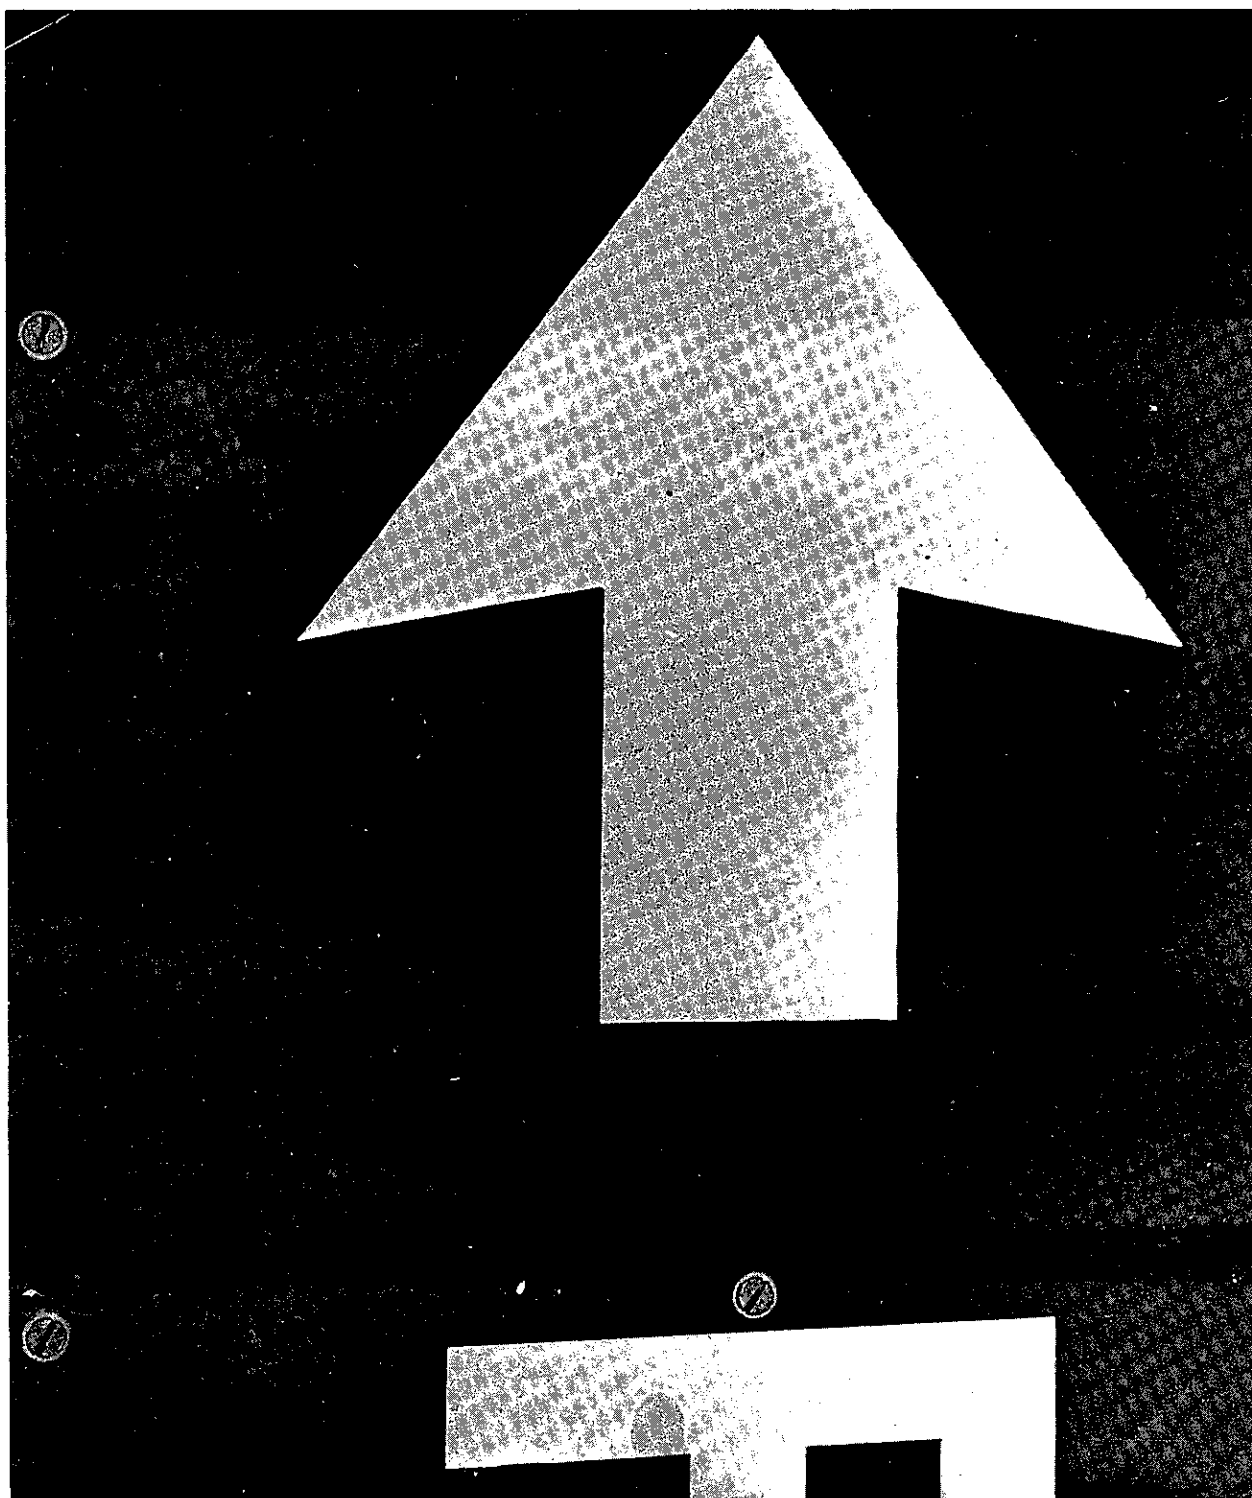
Shoulder-mounted, North exposed Silver Scotchlite legend on black porcelain enamel. No evidence of checking or peeling after 3 1/2 years service.

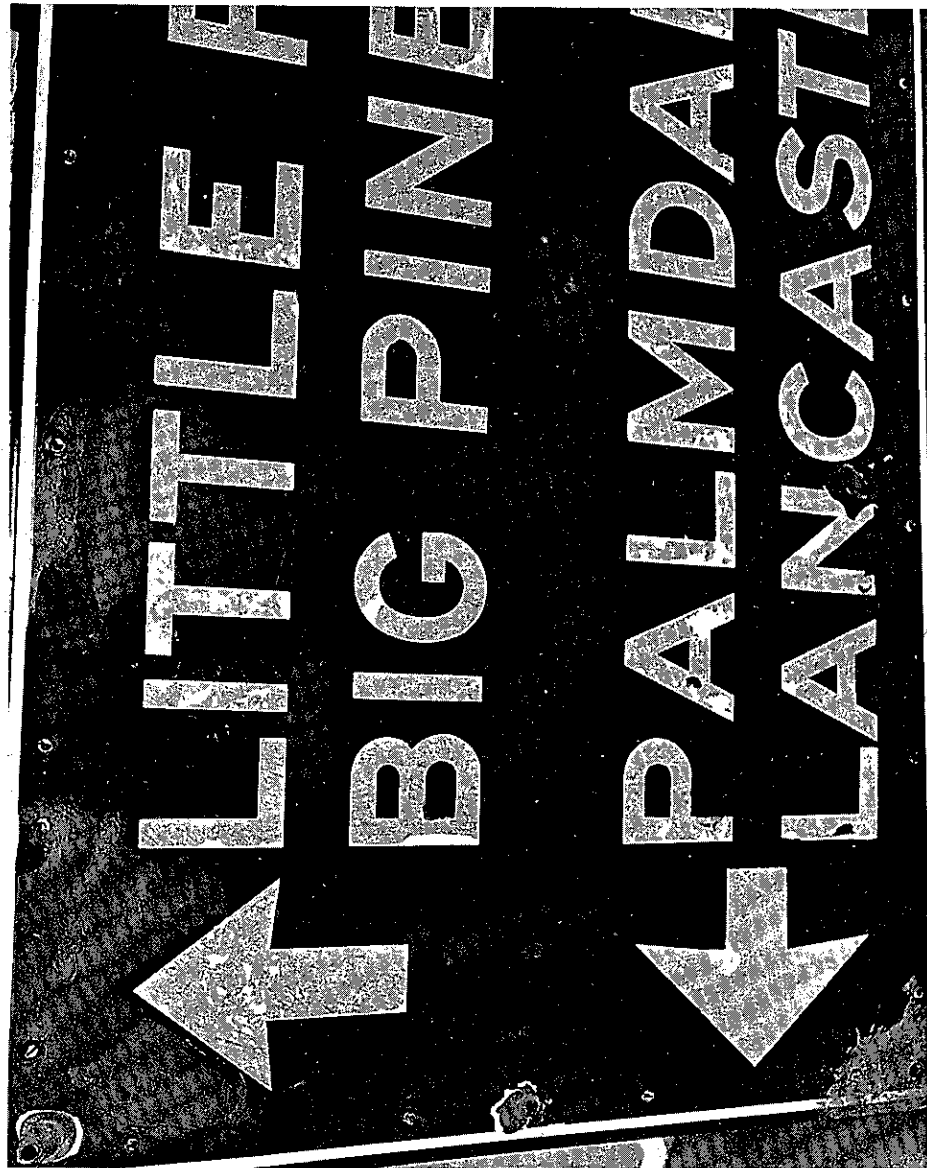
An example of deterioration and failure of a Scotchlite legend on porcelain enamel is shown in Exhibit 15. The sign was installed June 7, 1950, on VII-LA-23-E facing due west. By November 1954, the Scotchlite legend had completely failed and a new legend was applied by Cal-Metal Enameling Company. Exhibit 15 shows the present condition of this refurbished sign after an additional 4 years exposure.

Shoulder-mounted, West exposed Silver Scotchlite.
Legend on black porcelain enamel showing failure
of Scotchlite legend after 4 years Desert exposure.
